Iredell County – US 21

- Implementation Limits from Prison Camp Road to Southern Limits for the Town of Harmony
 - Completed December 13, 2008
 - Approximately 8.64 Miles
 - Part of Resurfacing
 - Before and After Observational
 - Located and Measured Ruts
 - Photo Log Documentation
 - Before – August 2008
 - After – July 2010 (~ 18 Months)
 - Cross Section 1 and 2

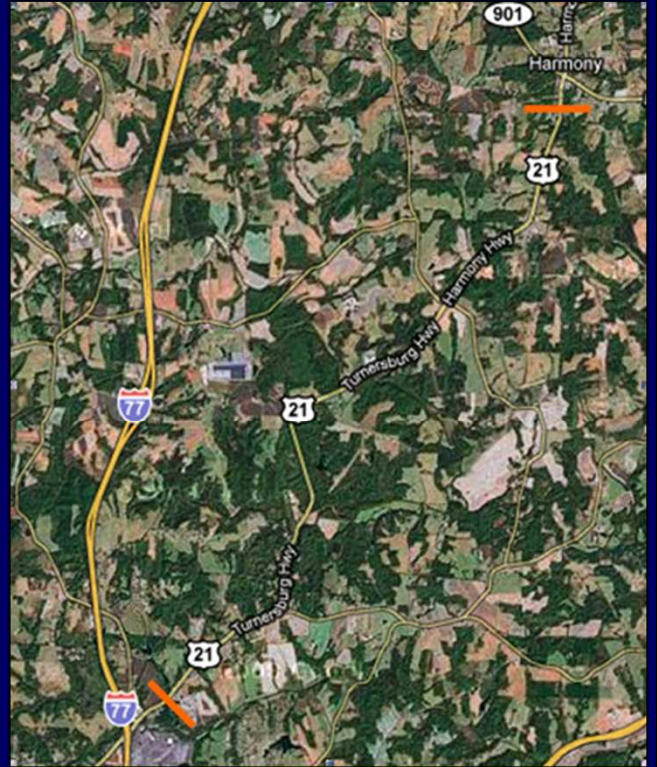
Lets explore the observational before and after data we were able to collect at the Iredell County installation on US 21 installed in December 2008. The before photos were taken in August of 2008 (~6 months prior to safety edge being installed) and the after photos were taken in July of 2010 (~18 months after safety edge being installed). The ruts were located and measured in the before and after period and photos were taken at these sites. The following eleven (11) slides depict some of the before and after photos that were collected at this site. The depth of the ruts are denoted on each picture. The left side is the before period, the right side is the after period. Field inspection at the 6 month after period mark verified that shoulders were pulled flush with new pavement lift. This was a standard resurfacing project and the cross-sectional width remained the same from the before to the after period.
